6 bd | 4 ba | 4,057 sqft

INSPECTION REPORT BY SIGNATURE HOME INSPECTIONS, LLC

1234 Main Street  
Colorado Sprngs , CO 80920

03/14/2023 9:00AM

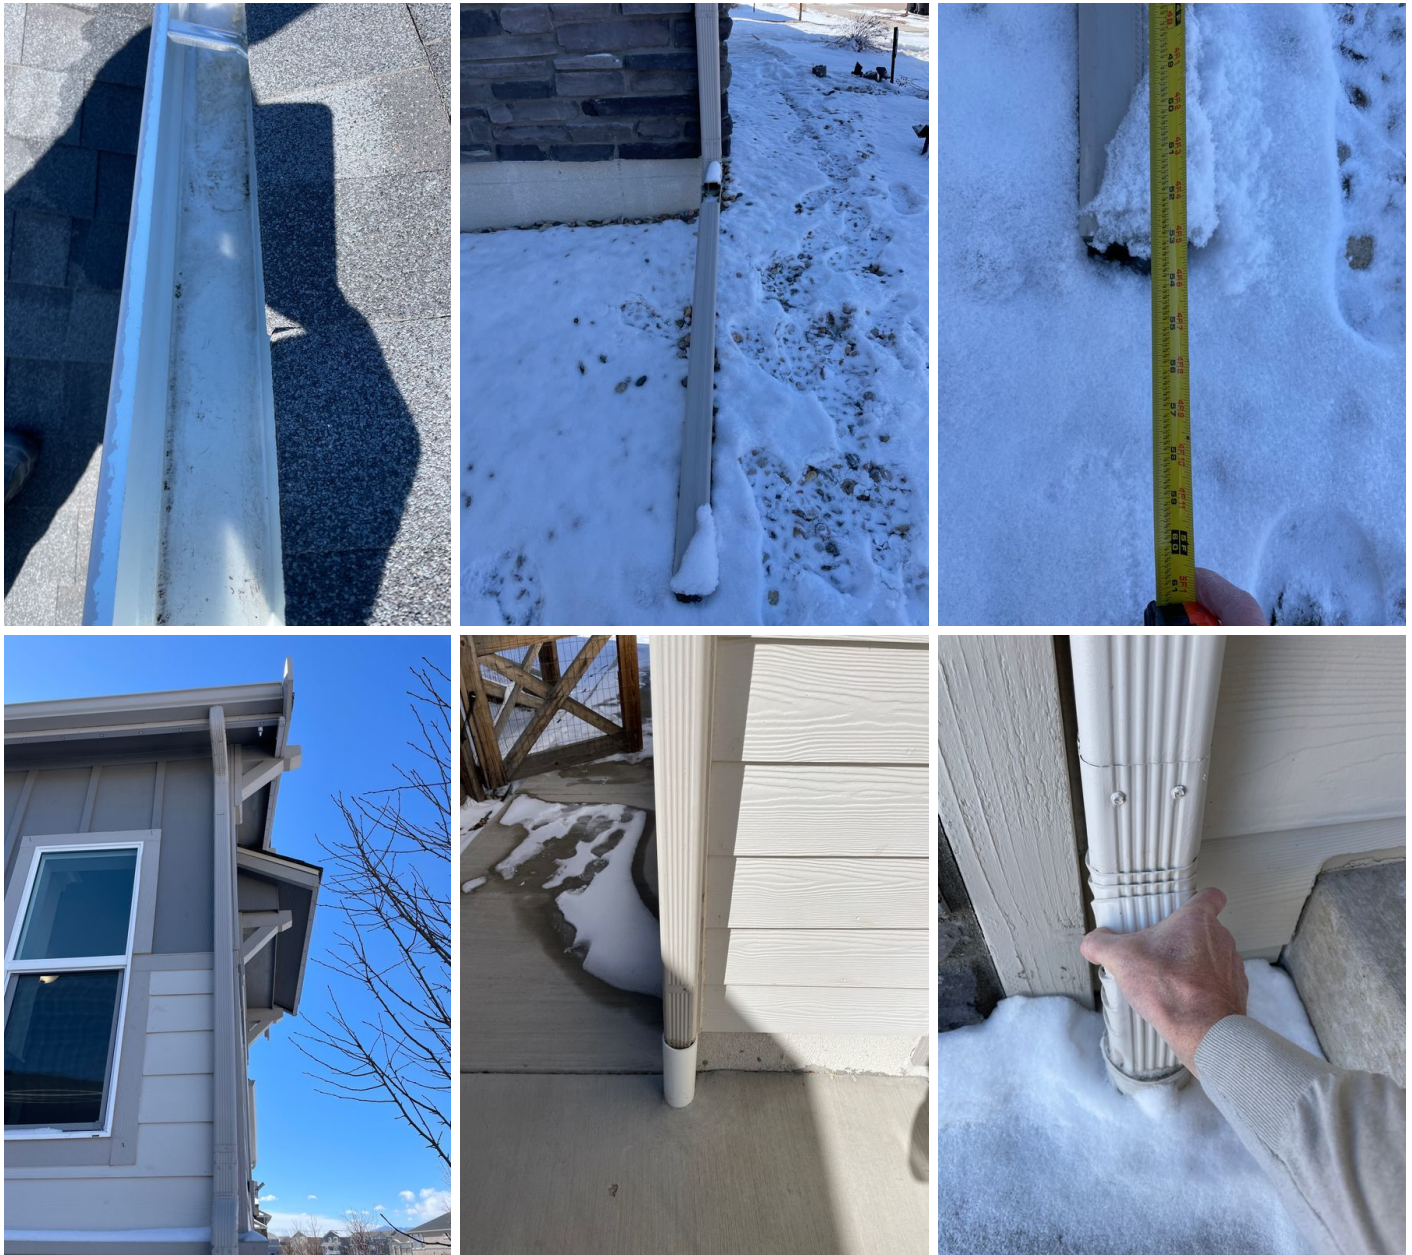
Inspected gutters for cracking, rust, and debris. Gutters in overall satisfactory condition. Some debris was found in gutters, loose leaves and pine needles.

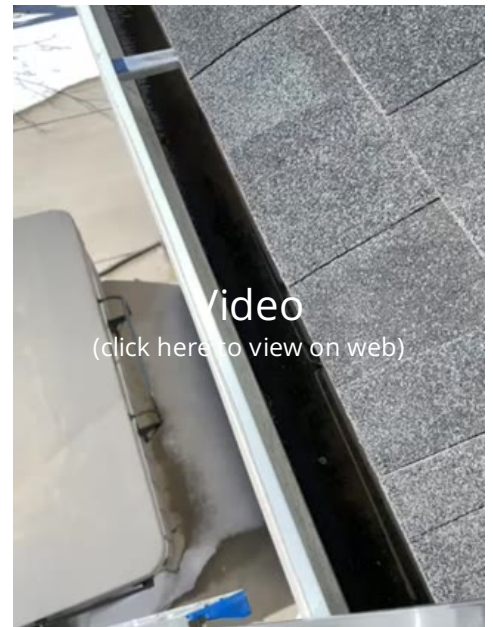
I observed debris in the gutter. Cleaning and maintenance is recommended.

Contact a qualified gutter contractor

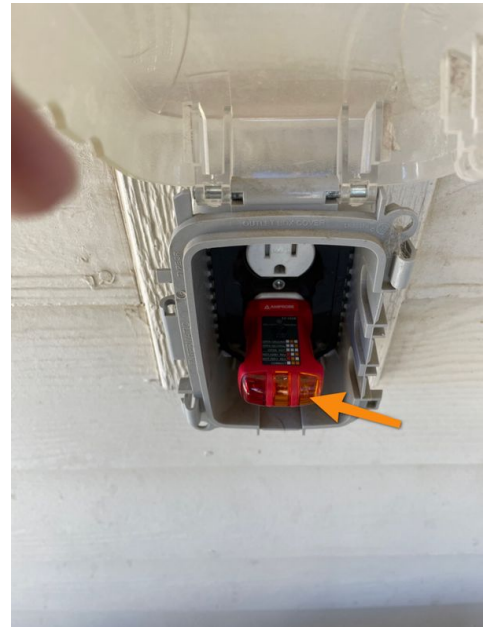
**ELECTRICAL DEFECT**

I observed indications of an electrical defect at the exterior. No power at receptacle.

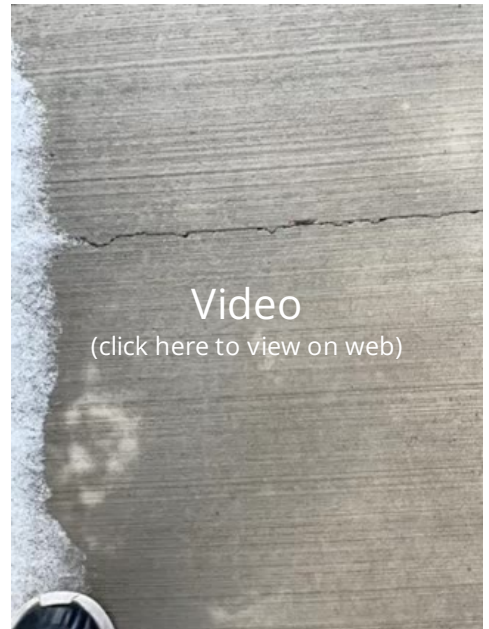
4.6.1 Walkways & Driveways

**MINOR CRACKING AT WALKWAY**

I observed minor cracking and no major damage at the walkway. Monitoring is recommended.

Contact a handyman or DIY project

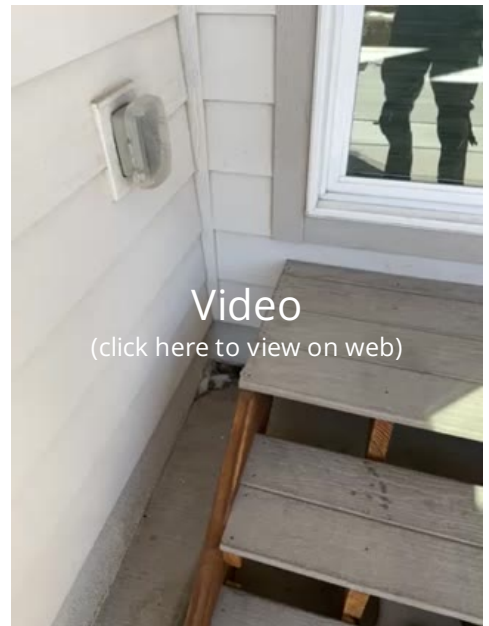
4.7.1 Stairs, Steps, Stoops, Stairways & Ramps

**MISSING HANDRAIL**

I observed a missing handrail at the exterior steps.

There is more than one step here, and I recommend installing a handrail for safety.

Contact a qualified professional.

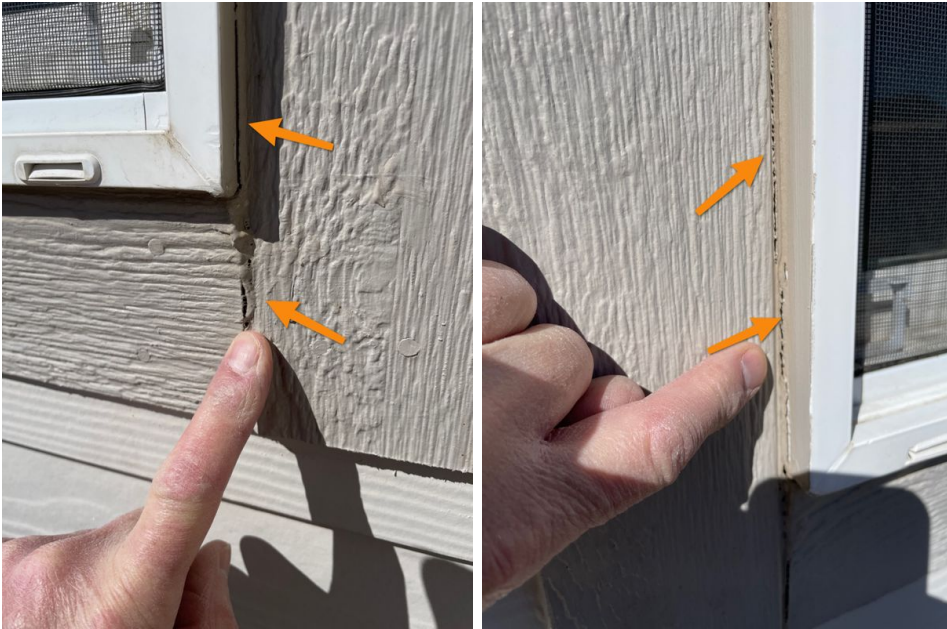
4.10.1 Windows

**CAULKING CRACKED AT TRIM**

Normal wear and tear, maintenance recommended.

Contact a qualified professional.

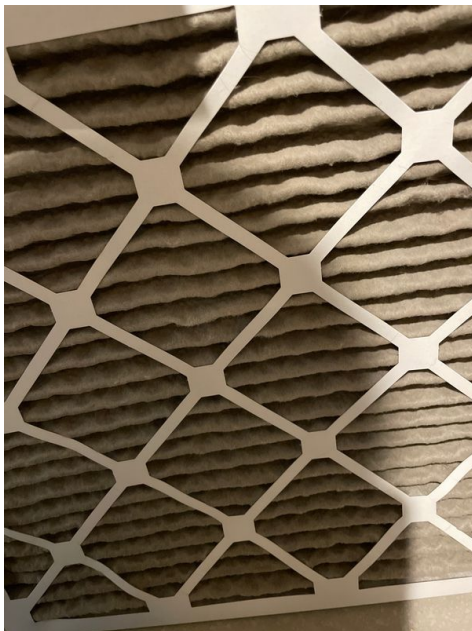
### 6.1.1 Heating System Information

I observed a dirty air filter at the furnace filter.

Recommended DIY Project

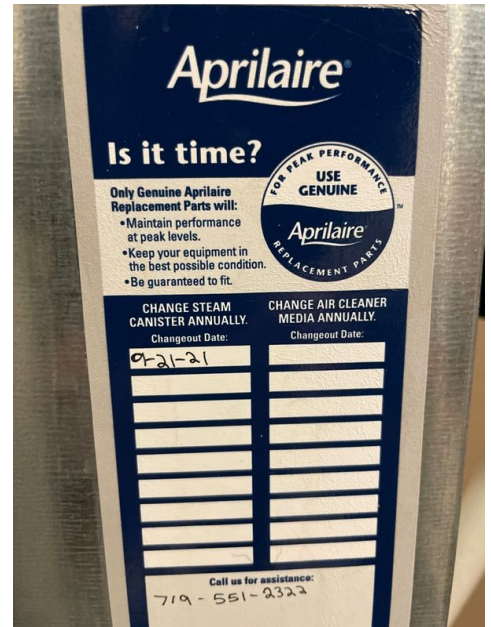
### 6.1.2 Heating System Information

#### **SERVICE TAG INDICATES DELAYED MAINTENANCE**

I observed indications of delayed maintenance at the heating system, because of the date of the most recent service on the service tag. The system should be cleaned and inspected by a HVAC professional every year. Correction and further evaluation is recommended.

Contact a qualified heating and cooling contractor

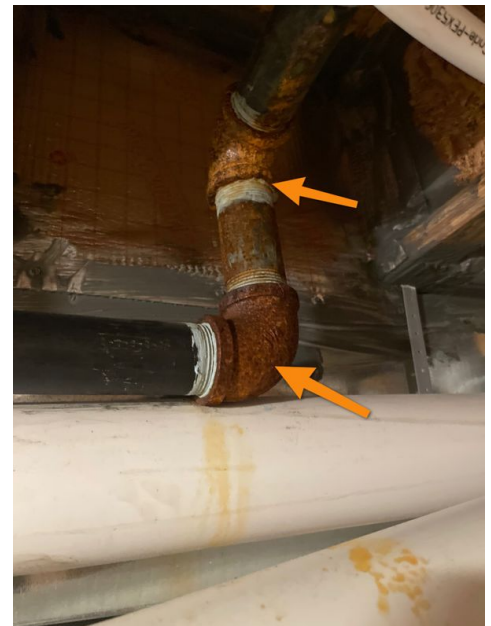
### 6.4.1 Check Gas Fittings

## CORROSION AT GAS DISTRIBUTION PIPING

Gas line above furnace has signs of 'corrosion' at the fittings.

Contact a qualified professional.

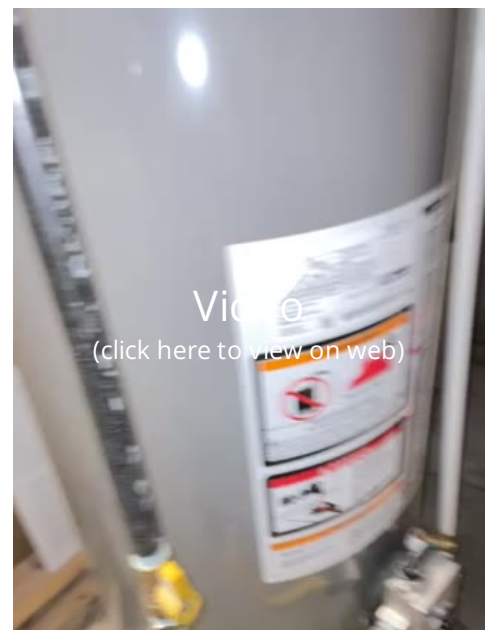
## **MISSING CATCH PAN UNDER TANK**

I observed that the hot water tank is missing a water leak catch pan.

Contact a qualified professional.

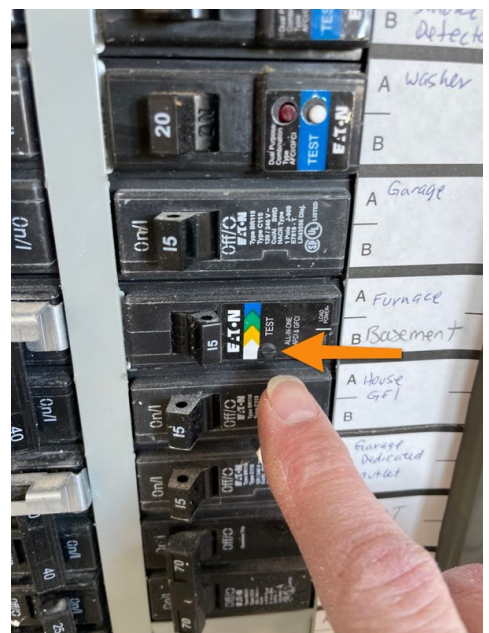
### OBSERVED A 15 AMP BREAKER IN 'TRIPPED' POSITION.

Contact a qualified professional.

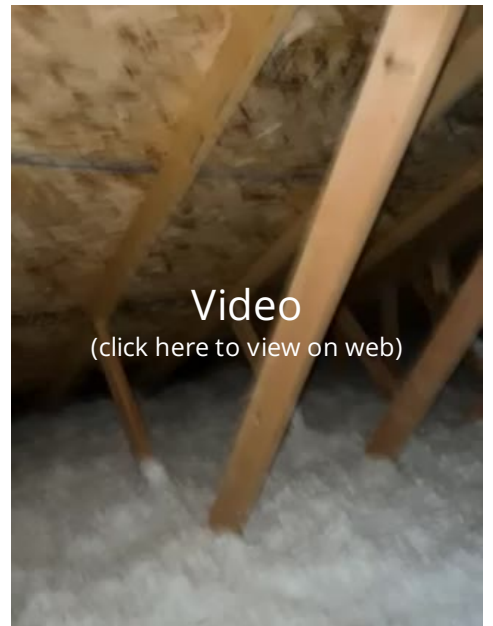
**LIGHT SOURCE MISSING IN ATTIC**

Attic light not present at the time of the inspection. According to the standards of practice there should be a light within arms reach or as soon as you enter through the attic access. This is a major defect.

Contact a qualified professional.

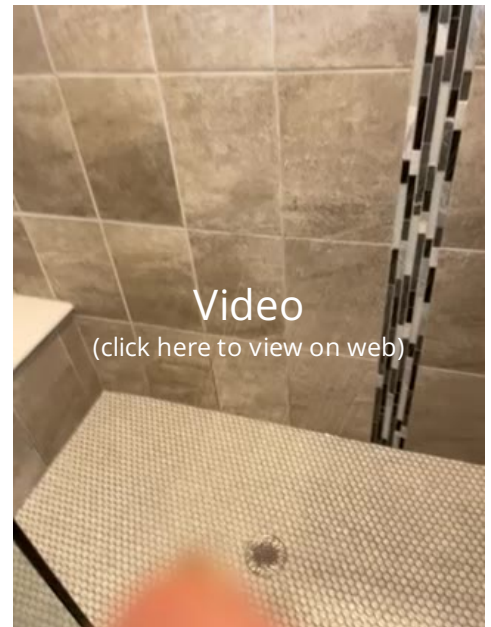
## 11.2.1 Sinks, Tubs &amp; Showers

**CAULKING FAILURE**

At the time of this inspection I observed the silicone caulking had pulled away from the glass enclosure in the Master Shower.

Contact a qualified professional.

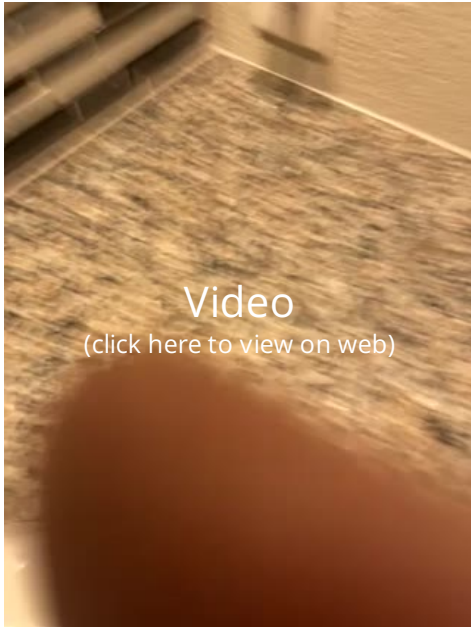
## 11.4.1 GFCI &amp; Electric in Bathroom

I observed a defect at the GFCI in the bathroom. It was not testing properly. Not functioning.

Contact a qualified electrical contractor.

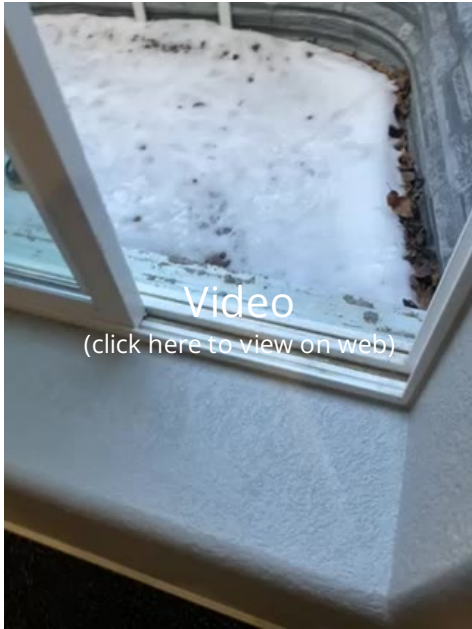
### MISSING WINDOW SCREEN

Contact a qualified window repair/installation contractor.

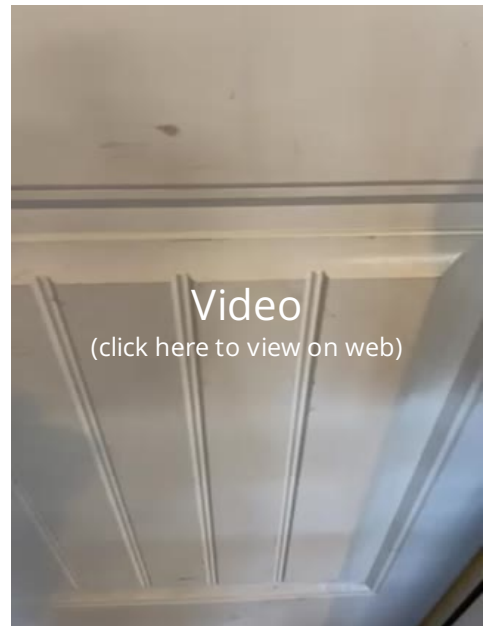
14.5.1 Ceiling, Walls & Firewalls in Garage

**DEFECT AT DOOR BETWEEN GARAGE AND HOUSE**

Contact a qualified general contractor.

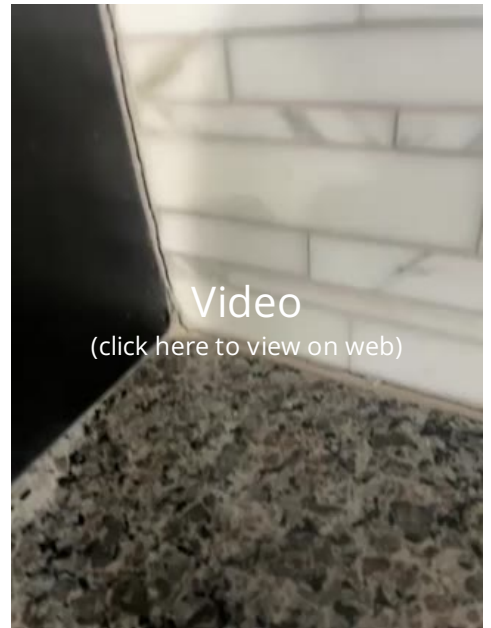
Kitchen Counter has Cracked Grout
